ASBESTOS SURVEY FOR THE SUPPLEMENTAL REMEDIAL INVESTIGATION

**Presidio of San Francisco
Modification to Phase II Environmental Study**

**Contract No. DAAA15-90-D-0018
Task Order 0002, Data Item A004**

**Prepared by:
Watkins-Johnson Environmental, Inc.**

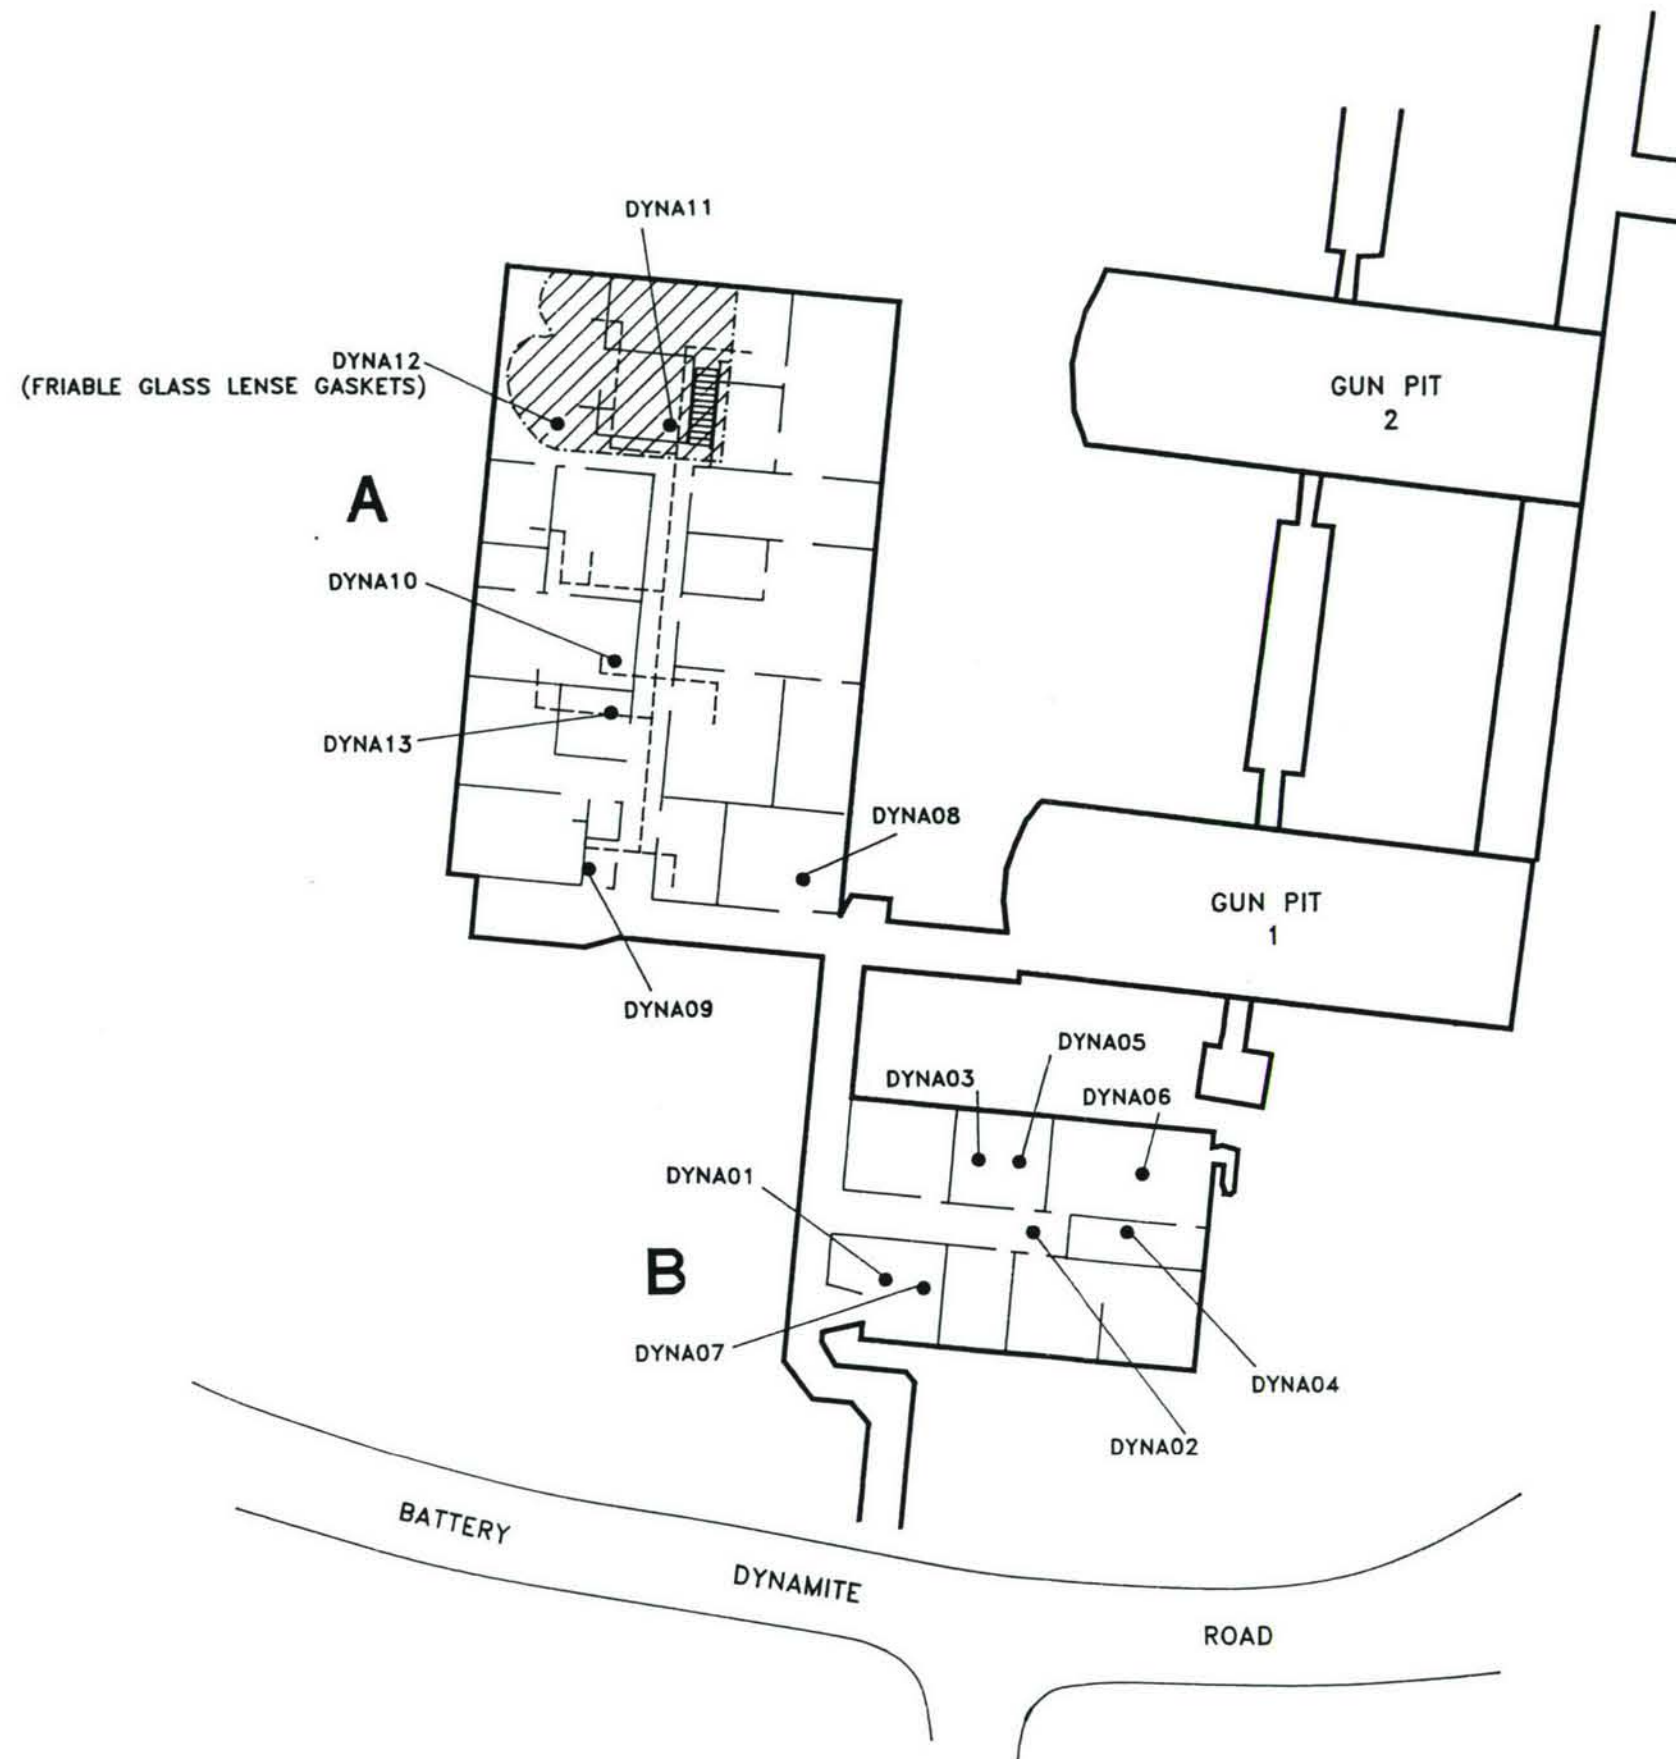
Battery Dynamite is constructed almost entirely of concrete; however, subsequent renovations made in increments included materials, friable and nonfriable, that were analyzed and found to contain asbestos. Thirteen bulk samples were collected during the building survey, eight of which tested positive for asbestos. Of the eight confirmed positives, five were friable. A partial floorplan of the building with all the sample locations is presented as Figure 3.6. Asbestos sample results for Battery Dynamite are presented in Table 3.4. Figure 3.7 delineates the approximate extent of the asbestos containing floor tiles, floor tile mastic, air cell and prefabricated thermal system insulation (TSI), gaskets and sealant.

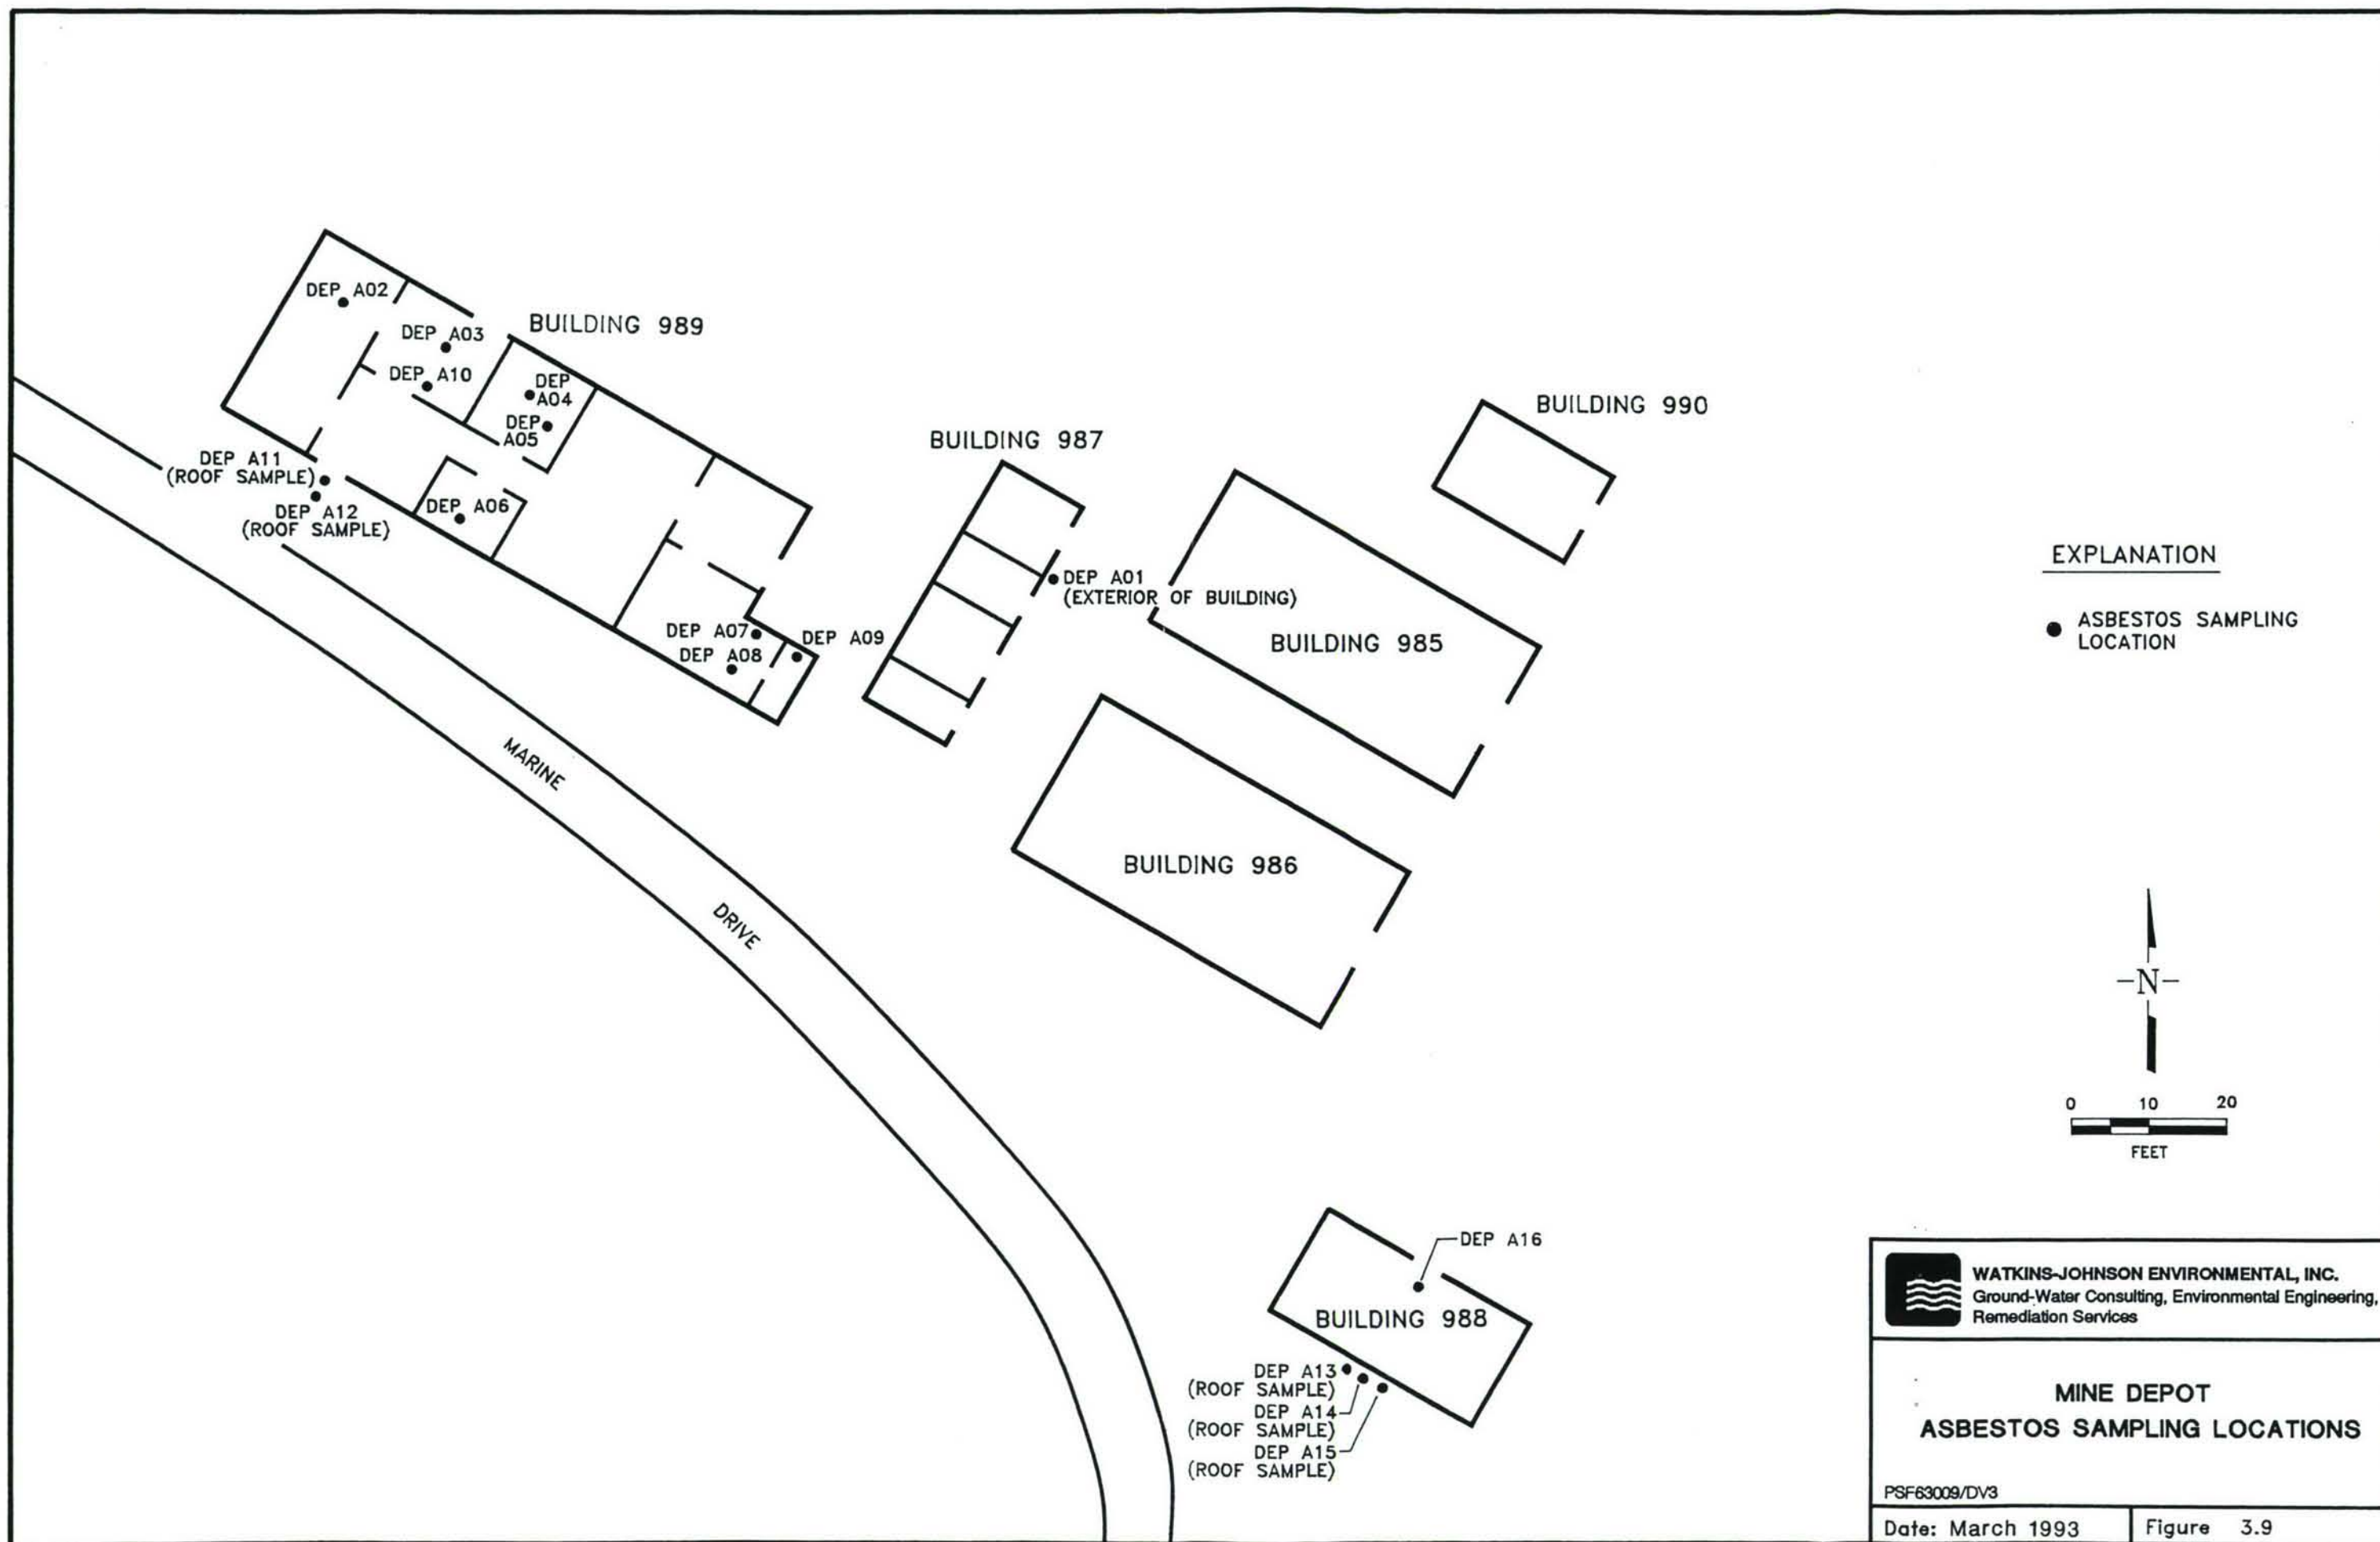
The Mine Depot (Buildings 979, 985, 986, 987, 988, 989, and 990) is located by the San Francisco Bay shoreline, about 1,400 ft east-by-southeast of the Golden Gate Bridge toll plaza. The Mine Depot buildings 985, 986 and 987 were constructed in 1907-1910. Building 979 housed the cables used to place the mines. Buildings 986 and 987 were used for storage of explosives. In 1908 the mining casemates were eliminated. A floorplan of the Mine Depot buildings with the sample locations is presented as Figure 3.9.
